Wildlife and power lines

Guidelines for preventing and mitigating wildlife mortality associated with electricity distribution networks

CASE STUDY 3

➔ Power lines and wildlife in South America

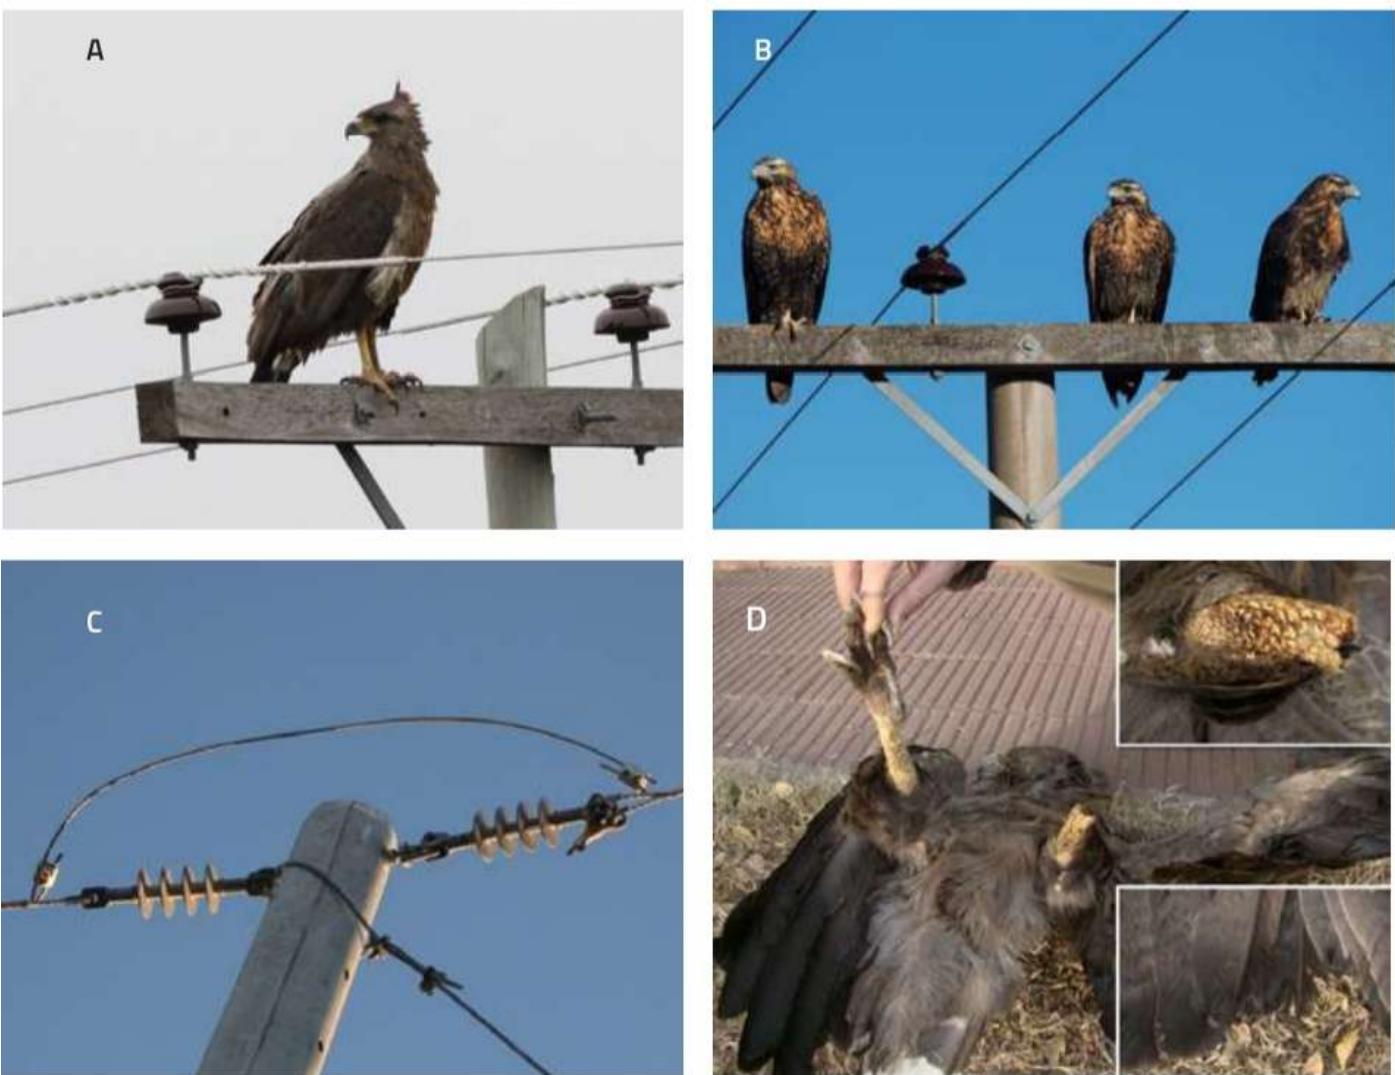
Figure 188. A: A juvenile Chaco eagle perched on a power line pole in western La Pampa province, Argentina. B: Juvenile black-chested buzzard eagles are among the raptor species most affected by electrocution mortality in southern South America, probably due to individual aggregations related to juvenile dispersal movements. C: Raptor electrocution is often reported on single-phase low-voltage lines in Argentina, particularly on steel-reinforced concrete poles with jumper wires, which are more dangerous for raptors. D: Note talons and part of tarsus of an electrocuted Chaco eagle that remained on the energised cable. ©J.O. Gjershaug, José Hernán Sarasola and Maximiliano Galmes/CECARA

(*Geranoetus melanoleucus*), variable hawk (*Buteo polyosoma*), turkey vulture (*Cathartes aura*), black vulture (*Coragyps atratus*) and Chaco eagle (*Buteogallus coronatus*) (Sarasola & Zanón-Martínez, 2017; Galmes et al., 2018). The Chaco eagle (Figure 188 A and D) is the only species of conservation concern in South America for which electrocution is considered a major threat to its populations, due to the high number of incidents in comparison with local abundances (Galmes et al., 2018) but also with regard to its global population size (Sarasola et al., 2020).

In Chile, apart from a single mention of an owl species, avian electrocution events are restricted to the black-chested buzzard eagle (Valenzuela, 2009; Alvarado-Orellana & Roa-Cornejo, 2010), which is also the species most affected by electrocution in Argentina (Ibarra & De Lucca, 2015; Sarasola & Zanón-Martínez, 2017). Notably, in both countries, juveniles comprised the bulk of the electrocution incidents involving this eagle species, which are probably related to the large aggregations of juveniles that form during dispersal in areas with high-risk poles (Figure 188 B).

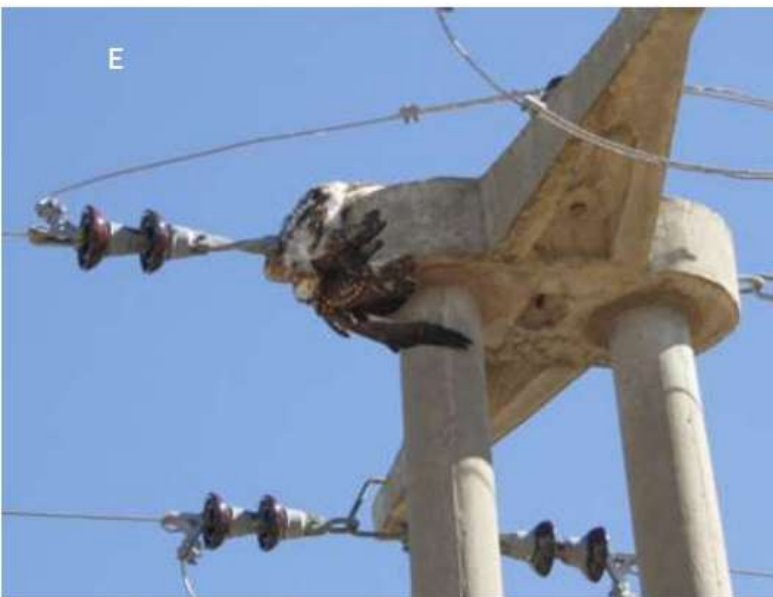
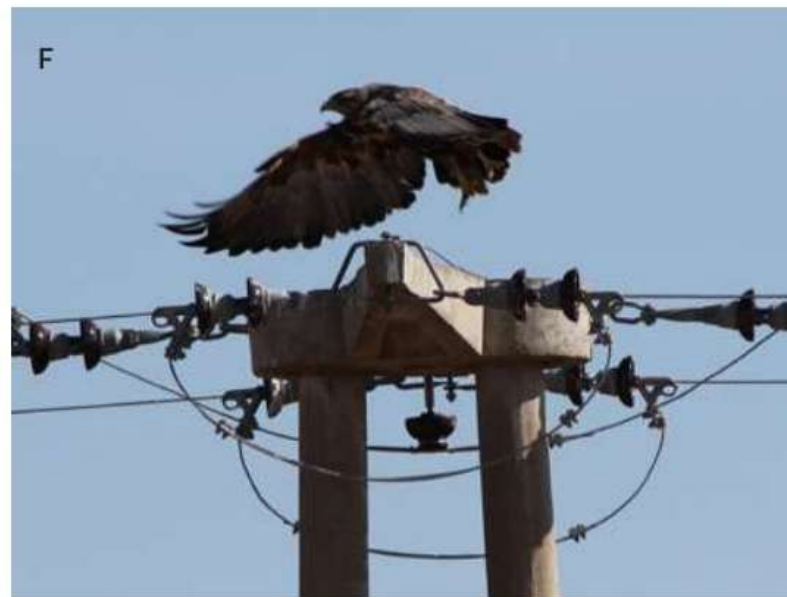
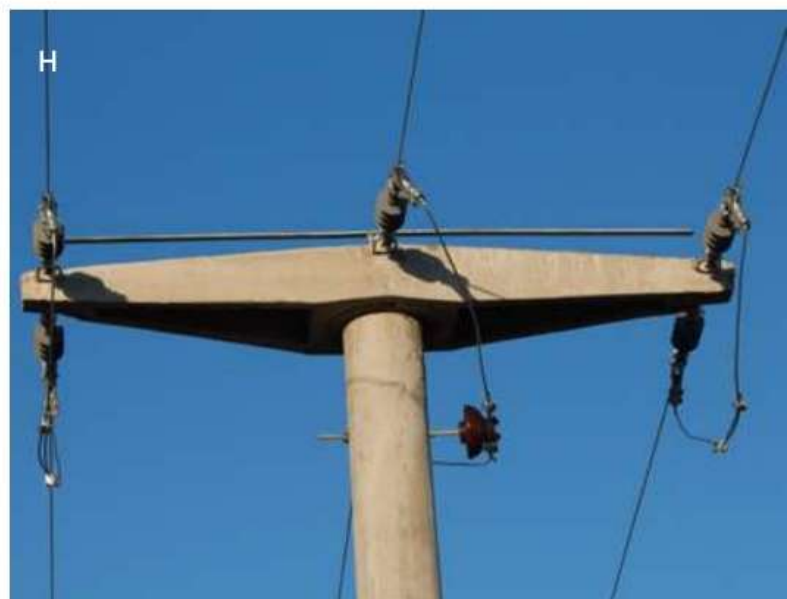
Figure 189. E: An electrocuted variable hawk in central Argentina on a pole combining wire jumpers above the crossarm with a dangerous construction material (steel-reinforced concrete). F: Black-chested buzzard eagle flying from a retrofitted pole where jumper wires were moved below the crossarm to reduce electrocution risk. G and H: Bird-friendly pole designs over 40 km of a newly built power line in Argentina. © José Hernán Sarasola and Maximiliano Galmes/CECARA

One of the groups of animals most frequently affected by electrocution on power lines is raptors, due to their behaviour and size. South America harbours almost a third of the globally recognised raptor species (Sarasola et al., 2018), but recorded electrocution incidents are anecdotal, with few events in Chile, Brazil and Argentina (Valenzuela, 2009; Alvarado-Orellana & Roa-Cornejo, 2010; Ibarra & De Lucca, 2015; Sarasola & Zanón-Martínez, 2017; Galmes et al., 2018; Gusmão et al., 2020; Sarasola et al., 2020). In these countries, electrocutions mainly occur on three-phase medium-voltage (12–13.2 kV) distribution lines. Additionally, in central Argentina incidents have also been reported on single-phase low-voltage (7.2 kV) lines, even though these are less common (Figure 188 C). Electrocution incidents are also linked to poles and crossarms made of conducting materials (e.g. steel-reinforced concrete or metal), and with jumpers above the crossarms. On these lines, birds perch directly on the top of the grounded pole with little clearance between themselves and a jumper wire attached to the top of the pole (Galmes et al., 2018; Sarasola et al., 2020; Figure 189 E).

In both Argentina and Chile, increased social awareness of avian electrocution resulted in the implementation of mitigation measures, which included retrofitting of power line pylons (Figure 189 F). However, such measures were implemented at a local scale (on particular poles) and not as part of conservation strategies at regional or country levels, with the exception of La Pampa province in central Argentina, where a power line of over 40 km was constructed to avian-friendly designs (Figure 189 G and H).
